Orrum PSO Alert – Cracks in Crescent Jugular Dual Lumen Catheter

Published: 9/16/24

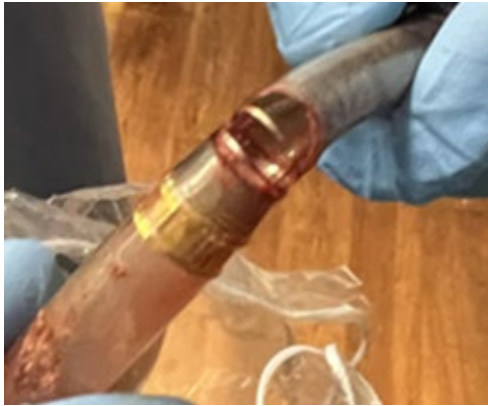
Image 1, left, and 2, right.

Location of Device Failure – In 12 reports (55%), the location of the fracture is not identified, but in nine of these reports (41% of total), air entrainment to the extracorporeal circuit is noted, suggesting these occurred in or near the extracutaneous portion of the cannula. In ten reports (45%), the location of the fracture is noted to be 1-2 cm proximal to the gold suture ring, as seen in the included photographs (Image 1, 2).

Location of Device Failure - Both PSO reports involved fractures in the cannula just “below” the gold suture ring (see images 1 and 2, below).

1. Consider the risk/reward of cannula exchange if the device is bent or otherwise damaged during preparation, insertion, or use.
2. Closely inspect the device prior to insertion for pre-existing damage.
3. Avoid and/or minimize lateral or shear (twisting) stress on the cannula before, during, and after insertion, to the extent possible.
4. After insertion or any manipulation/repositioning, fluoroscopic assessment should include close inspection for uneven spacing between wires, suggesting possible fracture development.
5. Increase surveillance of the device. Daily close visual inspection should be standard. Extra vigilance should be exercised in situations where;
 - a. The device use approaches or exceeds the 30-day FDA approval.
 - b. The patient is active/ambulatory and the device may be at an increased risk for bends or kinks.
